Laying Asphalt at Low Temperatures

A pilot project in the Netherlands

March 2012

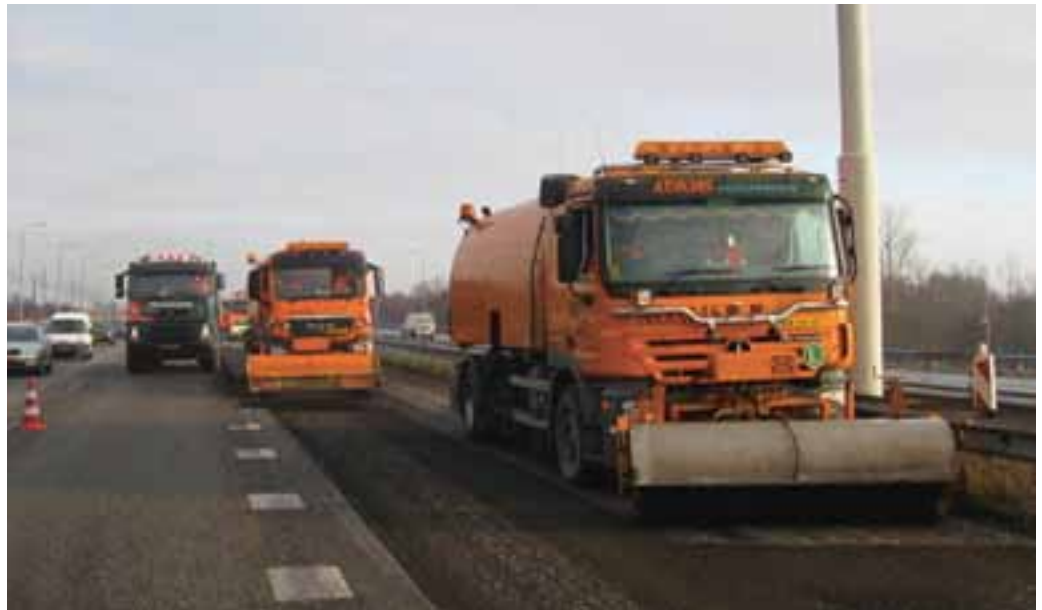
Plate 1: Cleaning a milled road surface.

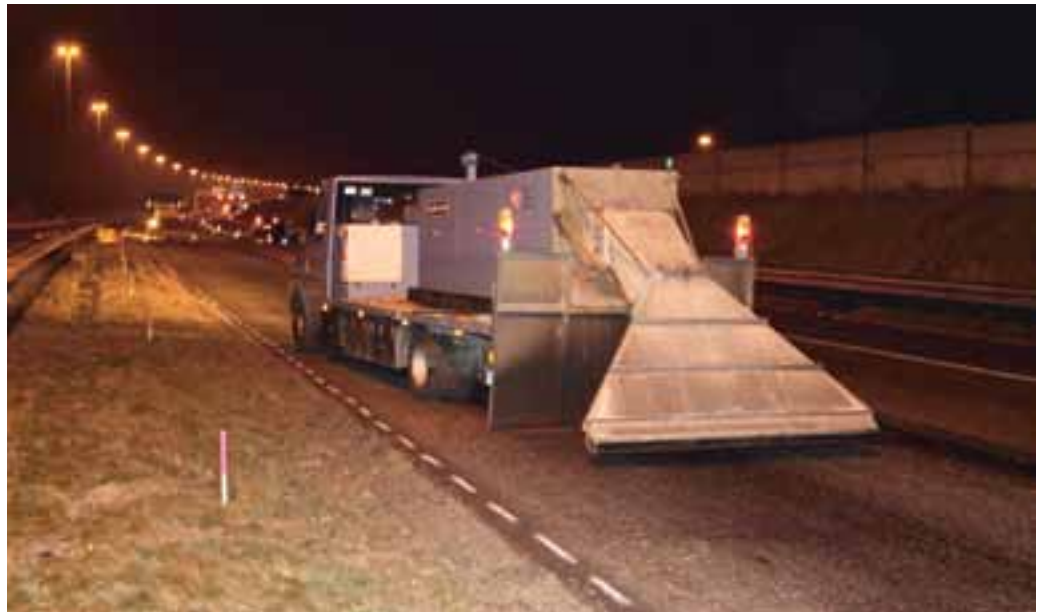
Plate 3: SurfaceJet.

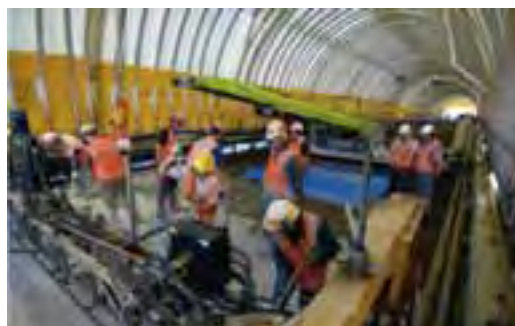
To protect delicate construction operations against the weather, shelters are sometimes erected over the site. Examples include the laying of high strength concrete on the Moerdijk bridge, part of the A16 motorway south of Dordrecht (2006), and the laying of poured asphalt on the Galecopper bridge, part of the A12 near Utrecht.

Plate 4: Working in a protective shelter.

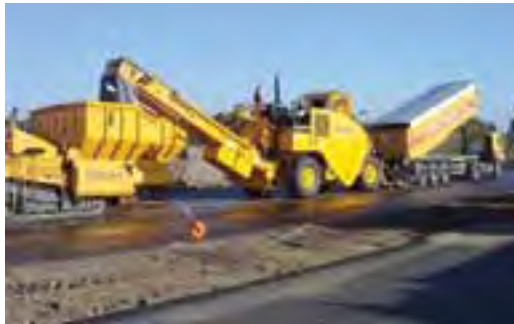
The Shuttle Buggy is a sort of container-on-wheels between the paver and the asphalt lorries. Used for remixing newly arrived asphalt, it ensures that the asphalt is returned to being a homogeneous mix in terms of temperature and composition. One major advantage is that the Shuttle Buggy holds a large supply of asphalt at the ready so that laying can continue unabated even if new deliveries are temporarily held up. Having no stop points improves the quality of the asphalt.

Plate 5: Shuttle Buggy.

Whether the use of a Shuttle Buggy will prove an advantage or a disadvantage when laying asphalt at low ambient temperatures is still a moot point. It may be that the extra storage time and the open conveyor belt from the Shuttle Buggy to the asphalt paver lead to faster cooling. When operating below zero it will almost certainly be necessary to use insulation to prevent excessive cooling. The physical speed of the asphalt paver is not increased by the use of a Shuttle Buggy, but without having to stop from time to time the average laying speed ought to be higher – a distinct advantage in wintry conditions.

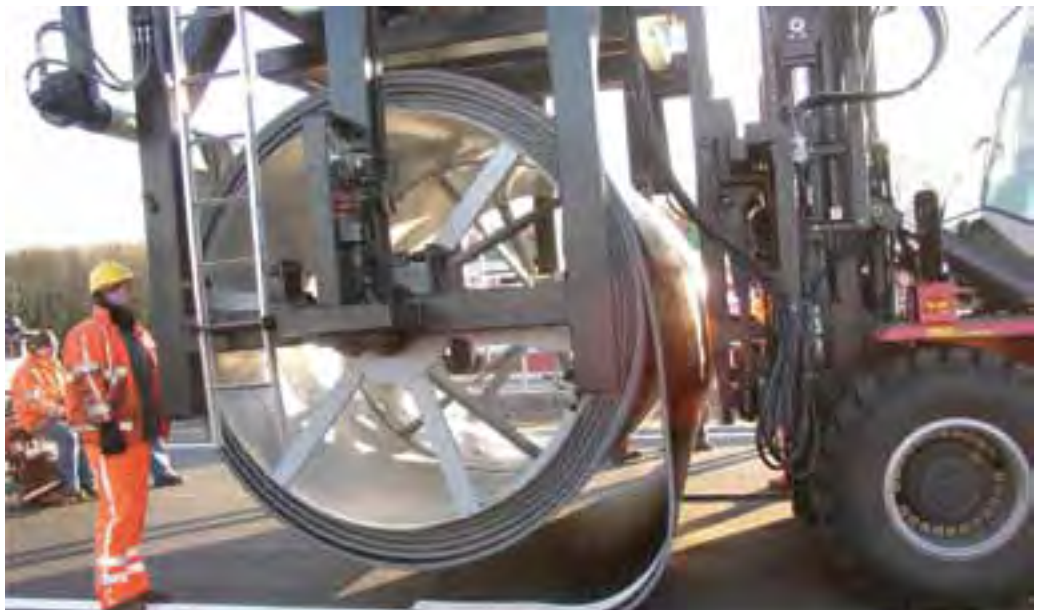
Rollpave was designed as a rollable noise-reducing asphalt layer. It is prefabricated under controlled conditions in a production facility and has a bituminous steel carrier mat. After production the Rollpave mat is rolled up and transported to the site, where it is unrolled and bonded to the sub-base by inductive heating.

Plate 6: Laying Rollpave.

As part of the Noise Innovation Programme (Innovatieprogramma Geluid, IPG) three test sections were paved with Rollpave. One of these was laid in sub-zero temperatures. As an extra measure the prefabricated mats were rolled up and packed in insulating material.

Rollpave's suitability as a means of laying an emergency road surface in below-zero temperatures is limited. Where frost damage has occurred in the form of excessive ravelling of PA the surface course will first have to be milled off, and since a newly milled surface is unsuitable as a sub-base for Rollpave the product is unsuitable as a means of repairing frost damage.

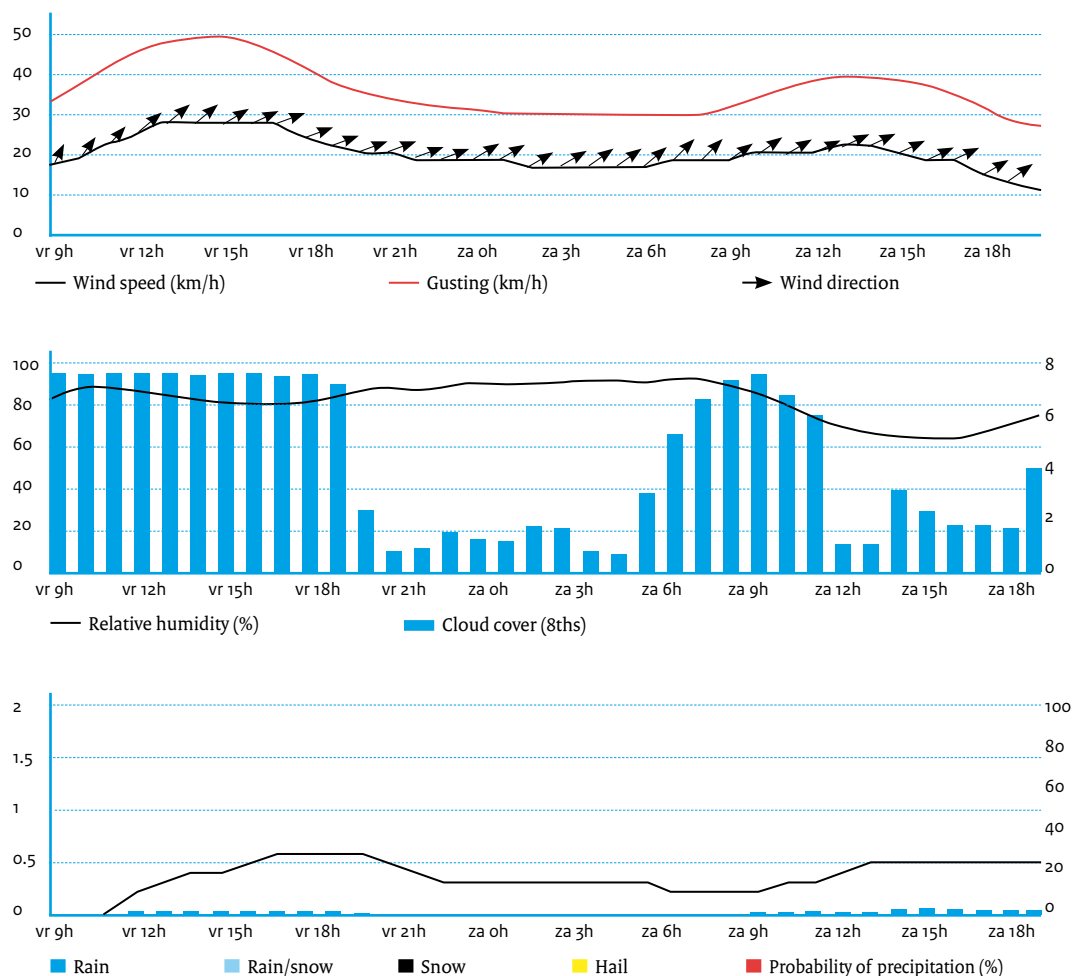
For the meteorological monitoring of the trial criteria MeteoConsult was brought in to provide effective local forecasting. Forecasts were based partly on data provided by sensors already embedded in the road surface as part of the existing ice alert system (GMS). Another factor taken into account was the precise location of the test sections and the effect of the surrounding landscape on wind speeds at the site, as well as height above sea level. On the basis of the advice given by MeteoConsult the ITC decided to issue a 'Frost Go' forty-eight hours in advance so that the trial could proceed on the night of Friday 19 to Saturday 20 February 2010.

Figure 2: 36-hour forecast based on data from the Galder automatic monitoring unit (source: MeteoConsult).

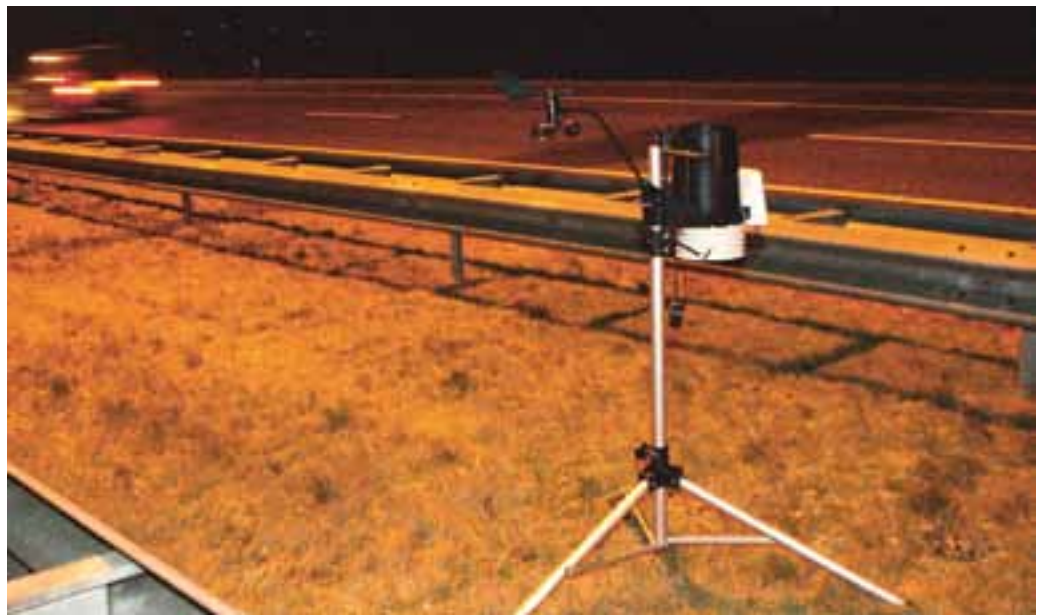
- Air temperature: -0.1°C ;
- Wind speed: 0.5m/sec ;
- Wind chill temperature: -2.3°C ;
- Road surface temperature: -3.9°C ;
- Precipitation: none

Plate 8: Mobile weather station in central reservation.

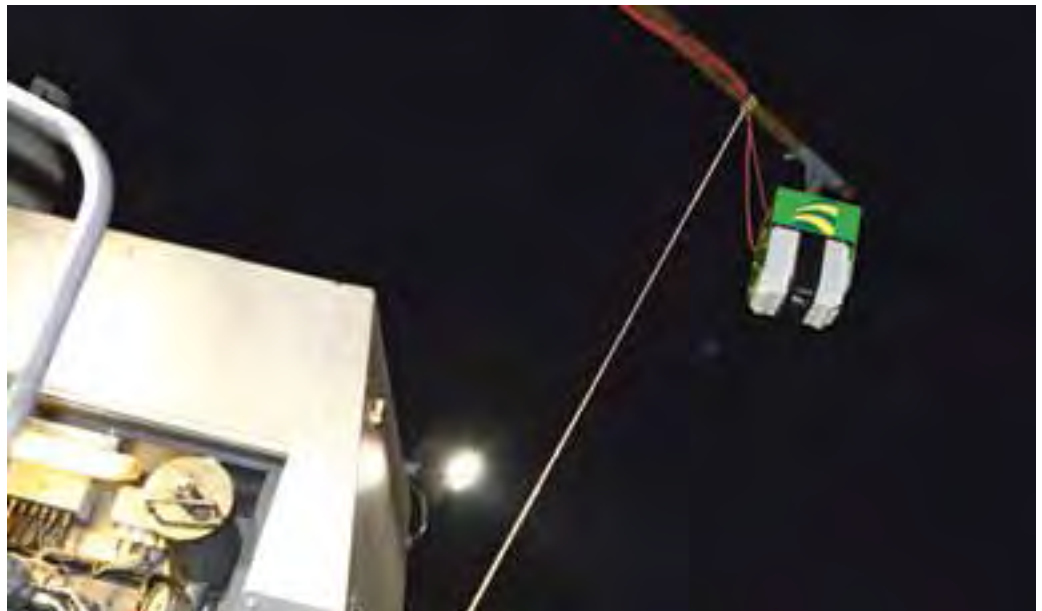
Plate 10: Infrared temperature camera mounted on paver.

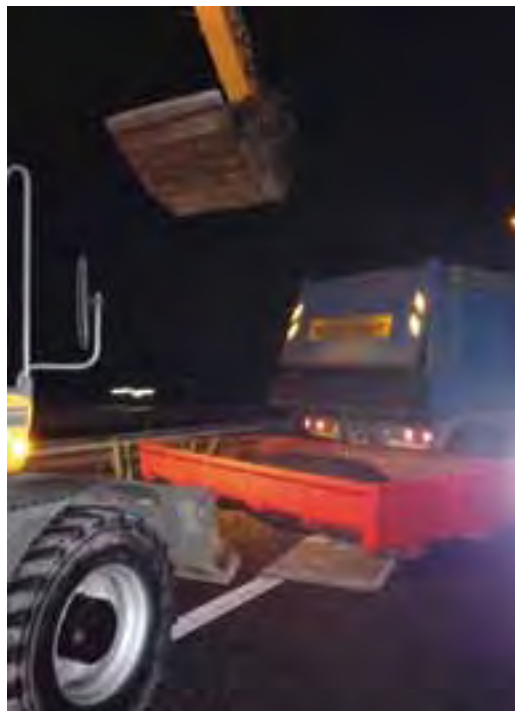
Plate 12: Separating off the coolest asphalt immediately behind the loading flap before the rest of the load is tipped into the hopper.

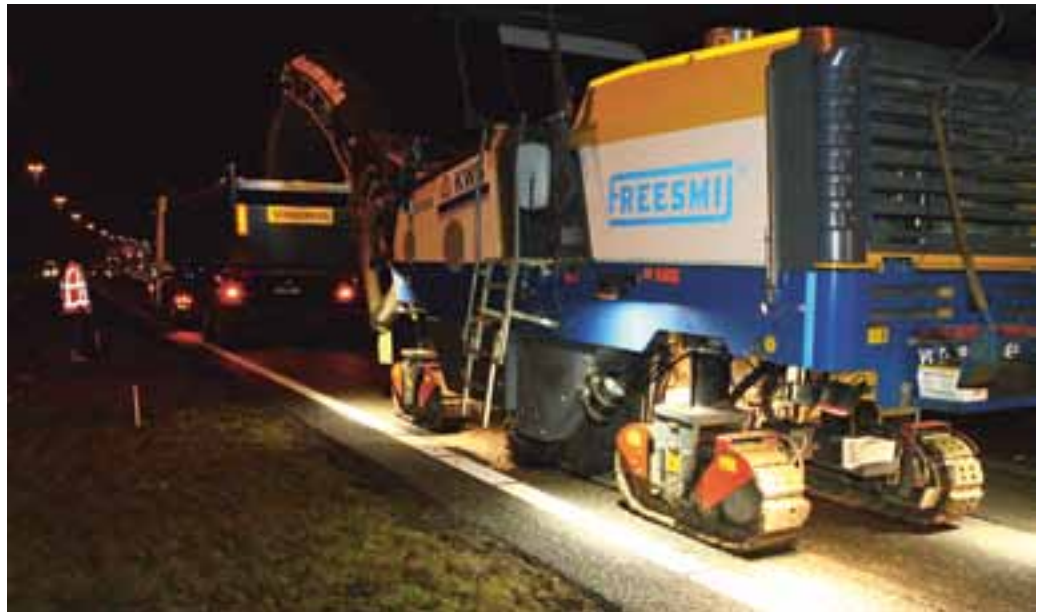
Milling was with ordinary road milling machines but without the use of water. Dust proved much less of a problem than expected, thanks in part to low wind speed. Particular points for consideration given the weather conditions were:

- Preheating the edges of the milling area with the SurfaceJet in order to avoid damage to the adjacent old asphalt;
- Comparatively low milling speed for a flatter binder layer;
- Vacuum sweeper with brush to ensure milling grooves are swept clean;
- SurfaceJet not only preheats but also blows binder layer extra clean and dry.

Plate 13: Milling off the wearing course and removing material.

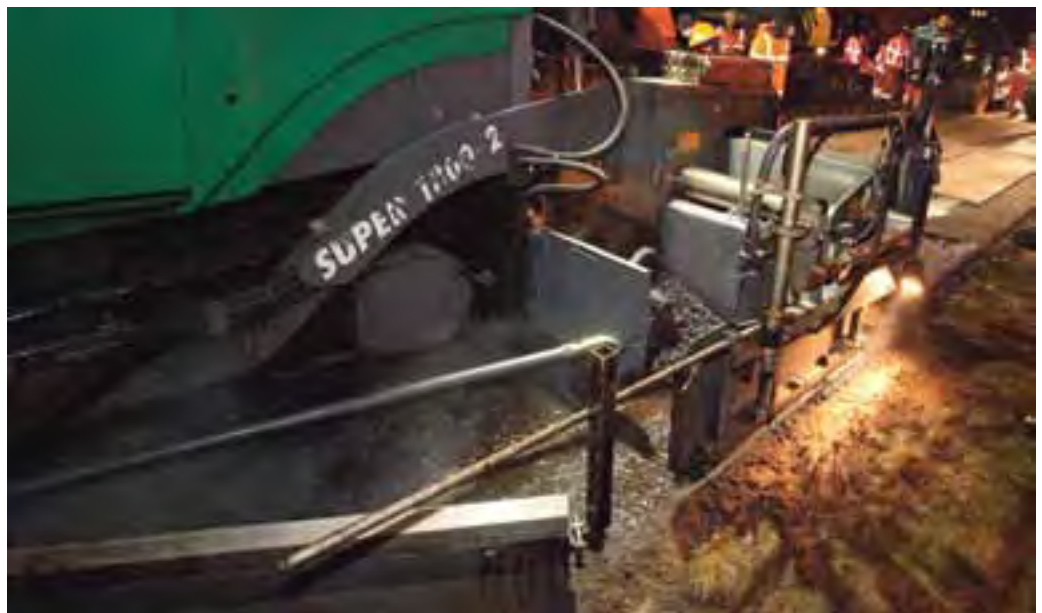
Both contractors opted for the use of a Spraylet paver so that applying the tack coat (a bitumen emulsion) was carried out in the same pass, immediately before the asphalt was laid. Direct contact with hot PA+ causes the bitumen emulsion to foam so that it can escape through the open texture asphalt layer, so this system provides optimum adhesion at low ambient temperatures. It also prevents tack coat material coming into contact with transport and handling plant and equipment, as well as ensuring that dust or dirt are not blown upwards where they can have an adverse impact on adhesion. When taking core samples it was found that PA adhesion to the binder layer was good.

Plate 14: Spraylet paver with integral spray bar.

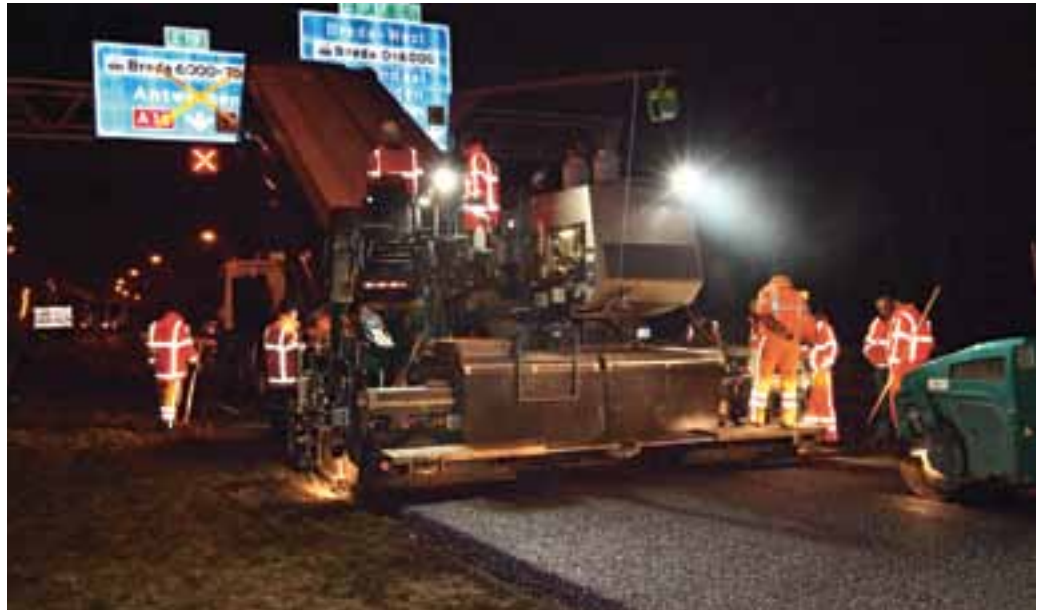
Plate 15: Asphalt paver closely followed by roller.

Rolling calls for considerable skill at all times, but even more so in wintry conditions when the quality of the final surface depends largely on achieving adequate compaction. With the more rapid cooling brought about by low ambient temperatures the trick is to design the rolling pattern so that enough roller passes can be fitted into the limited time available. Roller drivers were required to adhere to the following special instructions:

- Use the GPS system when compacting to determine when the number of passes stipulated by the contractor have been carried out;
- Work as closely as possible behind the paver;
- Keep passes short so that enough passes can be made within the critical temperature window;
- At low temperatures older PA is more brittle than usual, so as far as possible avoid contact with the existing PA abutting the working area.

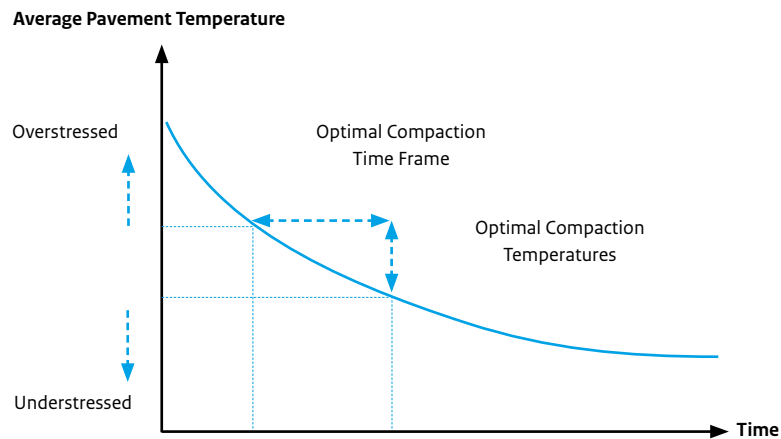
Figure 3: Compaction temperature window.

Compaction has to be carried out within a certain critical temperature range in order to minimize the risk of insufficient compaction. The relation between the critical temperature curve and the optimal time for compaction is shown in the graph⁴ above. Throughout the laying of the new test sections all roller movements were tracked by the GPS system. The results are discussed in paragraph 4.2.

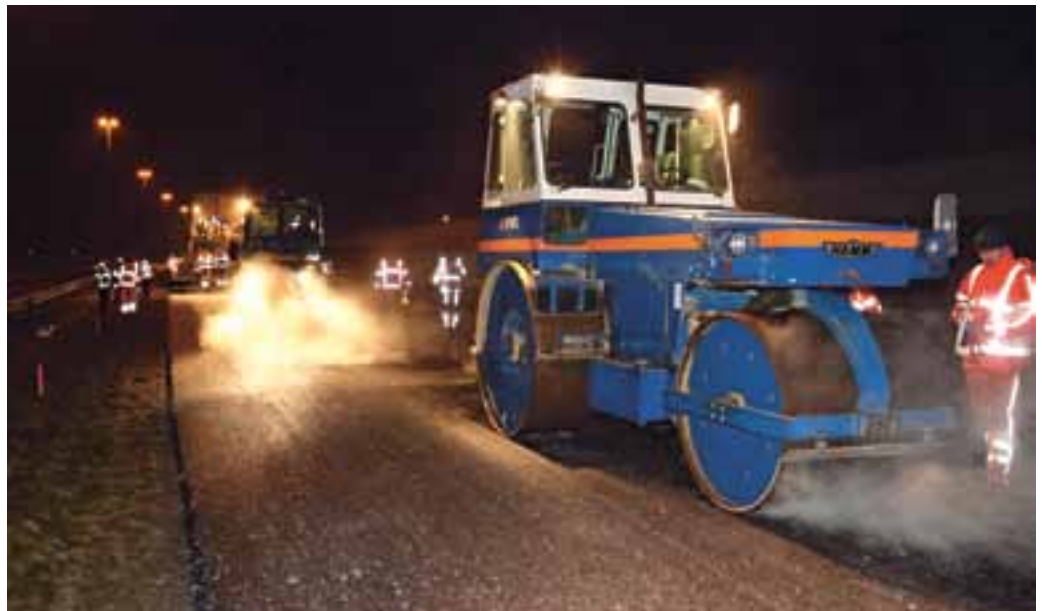
Plate 16: The water film sprayed onto the roller drums contains added glycol.

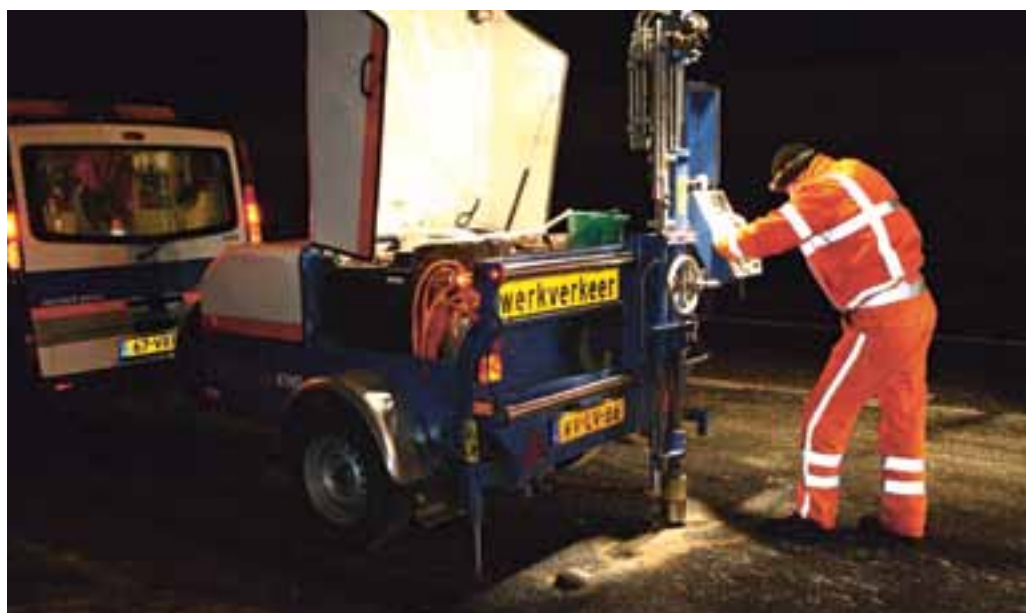
Plate 18: Taking core samples.

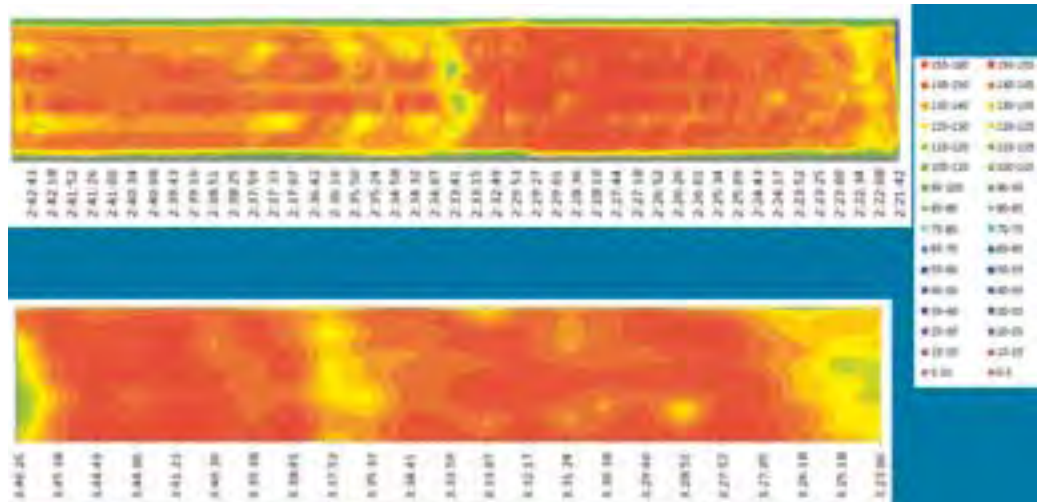
The special measures taken when laying the asphalt were discussed in paragraph 3.4. The temperature of the mix immediately behind the screed was monitored continuously over the full width using infrared cameras. It is possible to determine the homogeneity of a surface course by analysing fluctuations in temperature.

Figure 4: Temperature homogeneity when laying asphalt (temperatures in °C). (source: ASPARI, University of Twente)

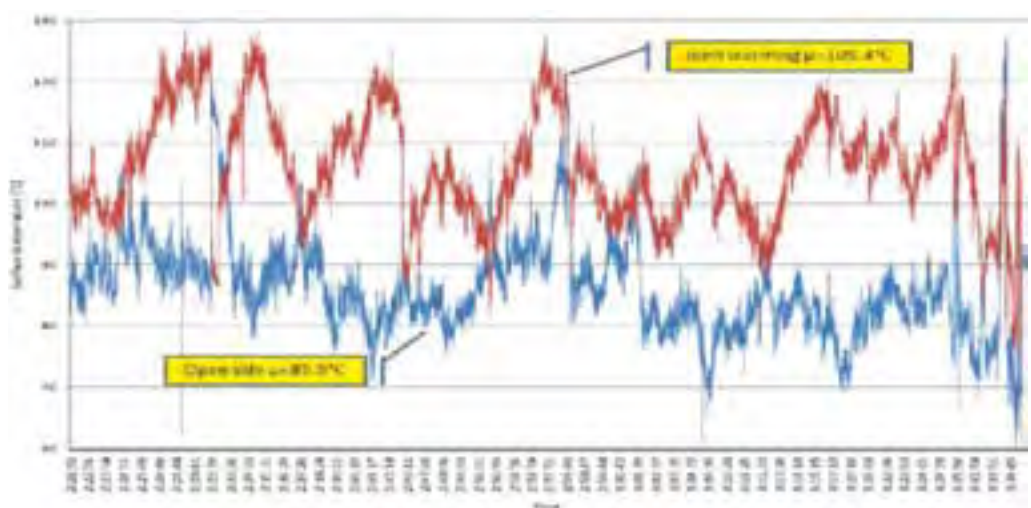
Preheating of the longitudinal joint was also measured. It will be seen from Figure 5 that the average rise in joint temperature due to preheating was approximately 20°C. (The red line indicates the joint heater; blue shows the absence of joint heating on the open side, i.e. where there was no adjacent asphalt.)

Figure 5: Preheating of the longitudinal joint: analysis. (source: ASPARI, University of Twente)

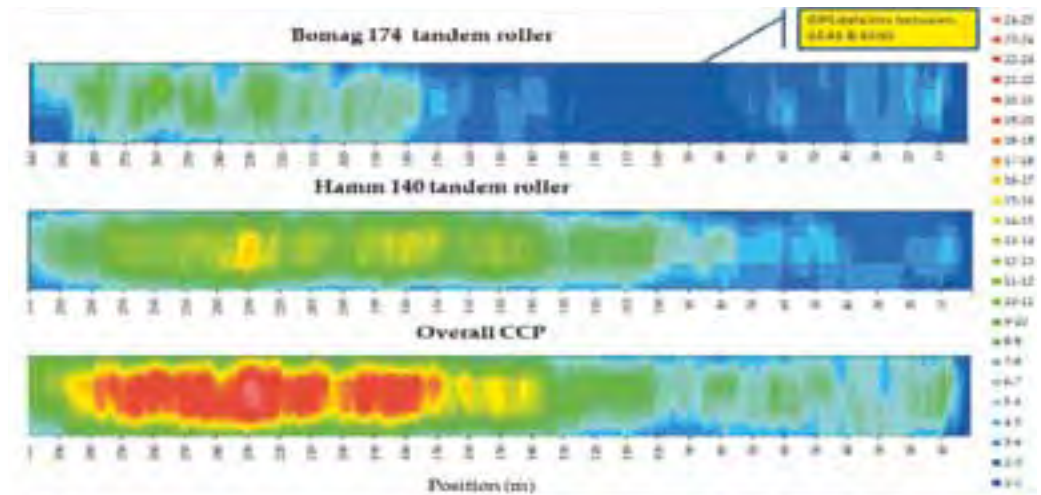
The movements of both asphalt pavers and rollers were tracked by GPS. By analysing GPS and temperature data together it is possible to establish after the event whether the rollers have compacted the asphalt as evenly as possible within the optimum temperature window. Combining GPS and infrared readings produces compaction contour plots (CCP). In Figure 6, for example, it is possible to see that the first hundred metres of one of the two test sections received considerably fewer roller passes than the next two hundred metres.

Figure 6: Compaction contour plots per roller and in total. (source: ASPARI, University of Twente)

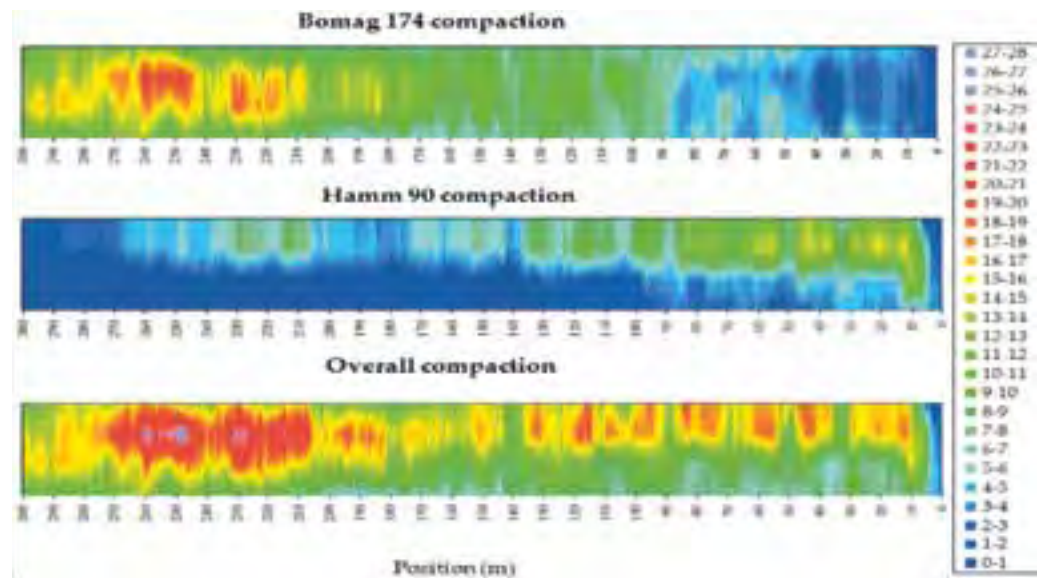
Figure 7: Compaction contour plots for the other test section. (source: ASPARI, University of Twente)

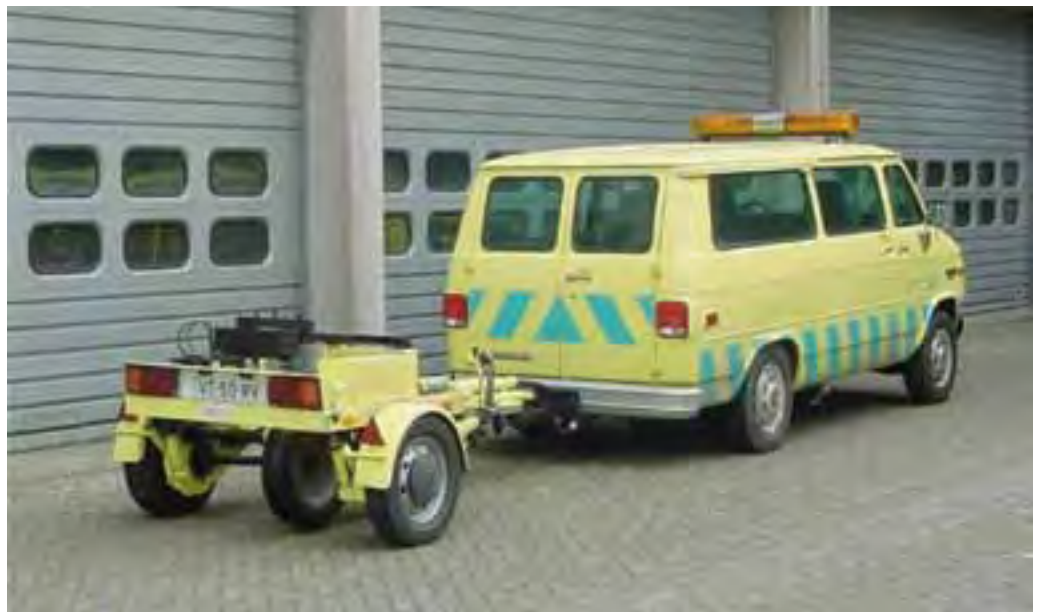
Plate 21: Pavement friction tester.

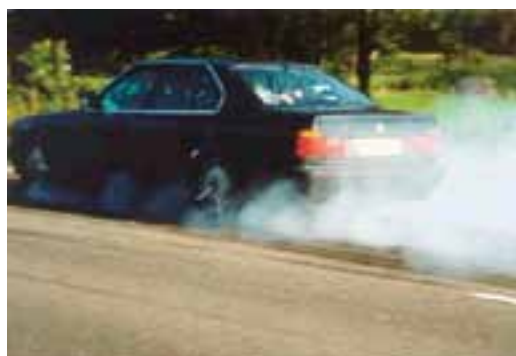
Plate 22: A brake deceleration test in progress.

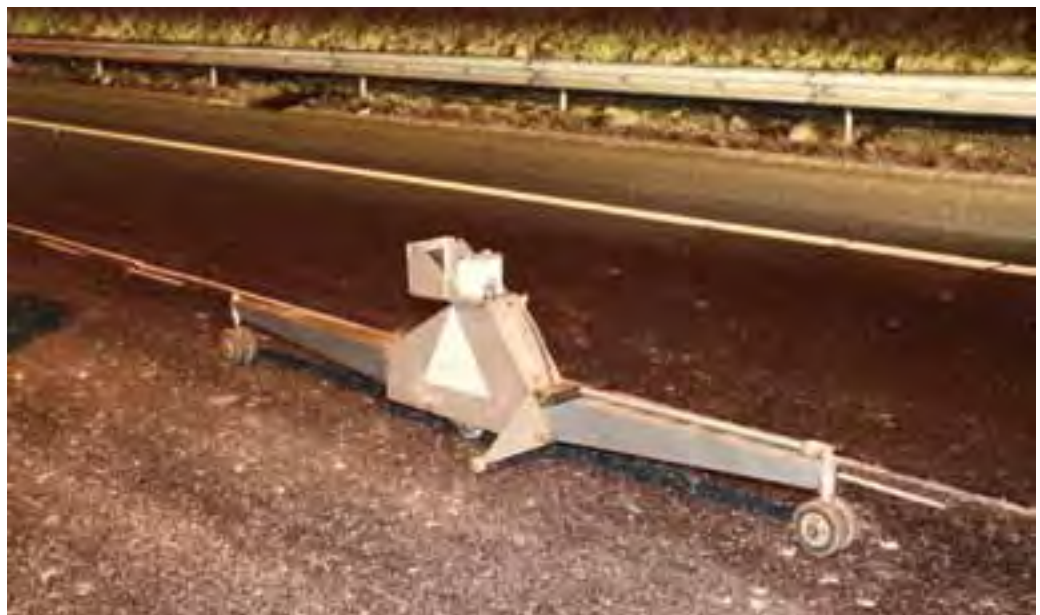
Plate 23: Rolling straight edge.

As part of the completion inspection longitudinal evenness was measured with a rolling straight edge in conformity with test 149 of the Dutch national standard RAW 2005. This is a standard procedure and is not discussed here since it is not expected to be relevant to the lower laying temperatures.

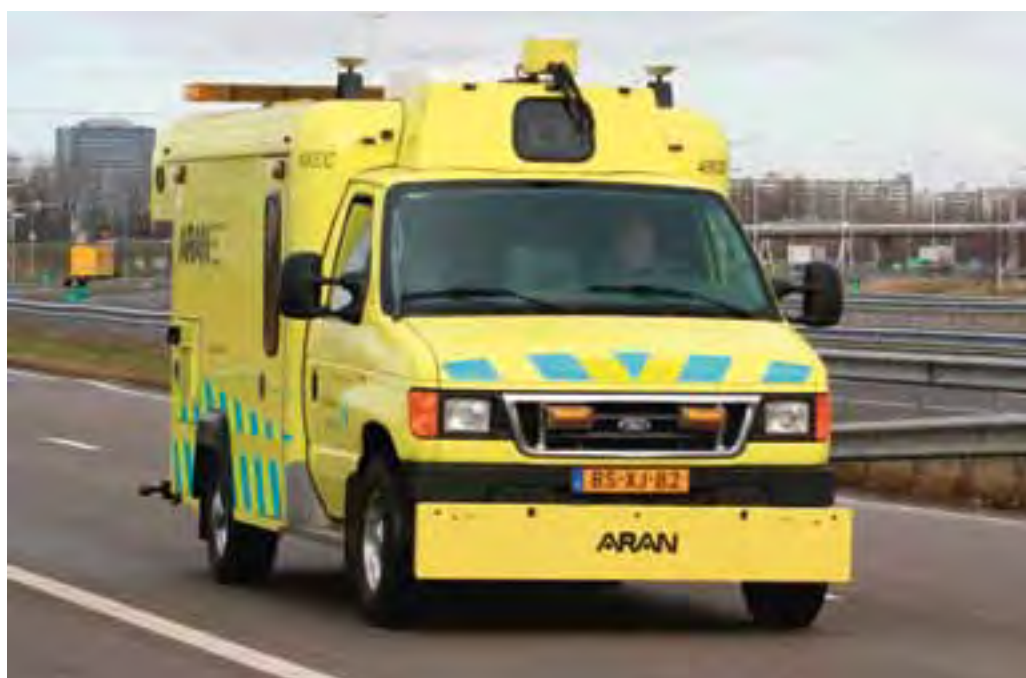
Plate 24: The Automatic Road Analyzer (ARAN).

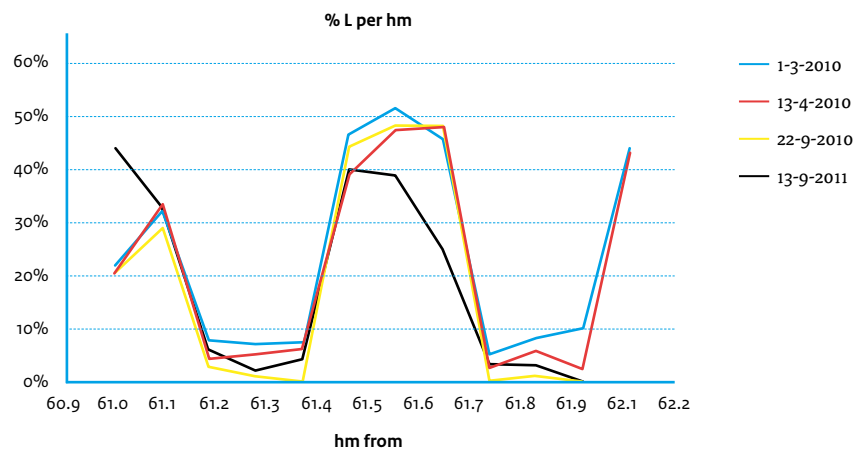
Figure 8: Percentages of light ravelling per hm per measuring date.

The laser measurements (see Figure 8) show that the percentage of light ravelling on the test sections is very low and considerably lower than on the adjacent existing PA areas. Nevertheless, there does appear to be a downward trend in the test sections in the first six months, followed by a rising trend. This effect appears not to exist in the adjacent sections. One explanation for the apparent decline in ravelling at the start may be abnormal reflections on newly laid PA due to the gloss of bitumen and/or the presence of blinding material or chippings. Once the mastic film has been worn off the laser saw ravelling develop according to the pattern expected: a very limited increase is seen some six months after the initial decline in measured ravelling. The percentage of moderate and severe ravelling is zero for both test sections. Figures 9 and 10 also show that there was virtually no ravelling in the test sections; this is in line with experience on PA sections laid under normal weather conditions.

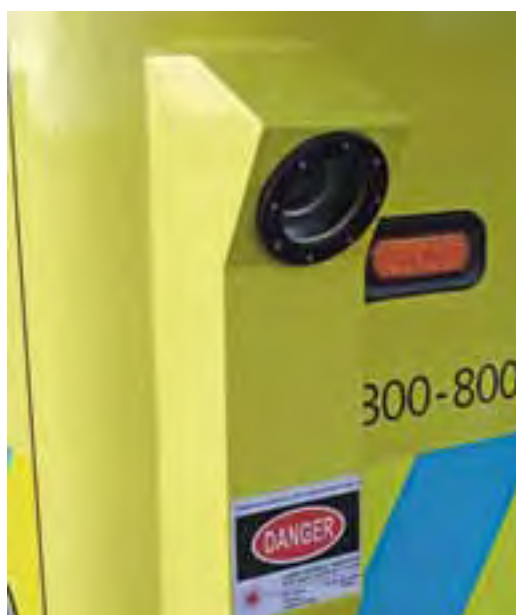
Plate 25: A laser on the ARAN.

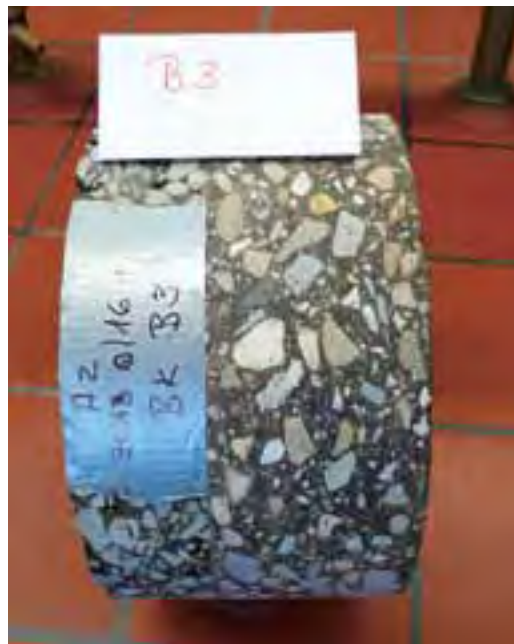
Plate 26: Core sample Ø 150mm.

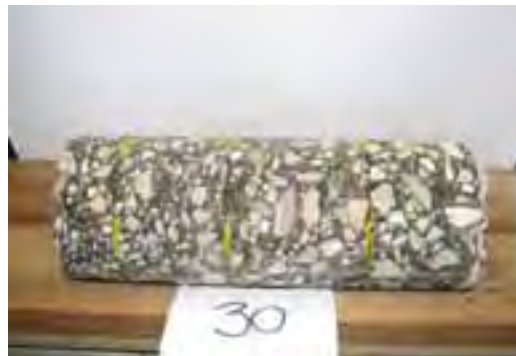
Plate 27: Core sample 100mm.

To determine water sensitivity, tests for indirect tensile strength were conducted on unconditioned and water-conditioned core samples. The ITSR (Indirect Tensile Strength Ratio, the ratio between the indirect tensile strength of unconditioned and water-conditioned core samples) establishes the sensitivity to water of the PA+ as prescribed by NEN-EN 12697, part 12. The requirement of ISTR80 for the sensitivity to water of PA as set out in RAW 2010 applies to mixtures compacted by a gyratory compactor, so that the results of the test on core samples can only be interpreted as indicative. If it is assumed that, as a result of being drilled through, core samples will automatically give a worse result, it may be concluded that the PA+ mixes laid below freezing point offer good resistance to water sensitivity.
